# Flash Flooding in Downtown Columbia, South Carolina

Gregory L. Lamberty\*, Michael W. Cammarata NOAA, National Weather Service, Columbia, South Carolina  
Email: greg.lamberty@noaa.gov

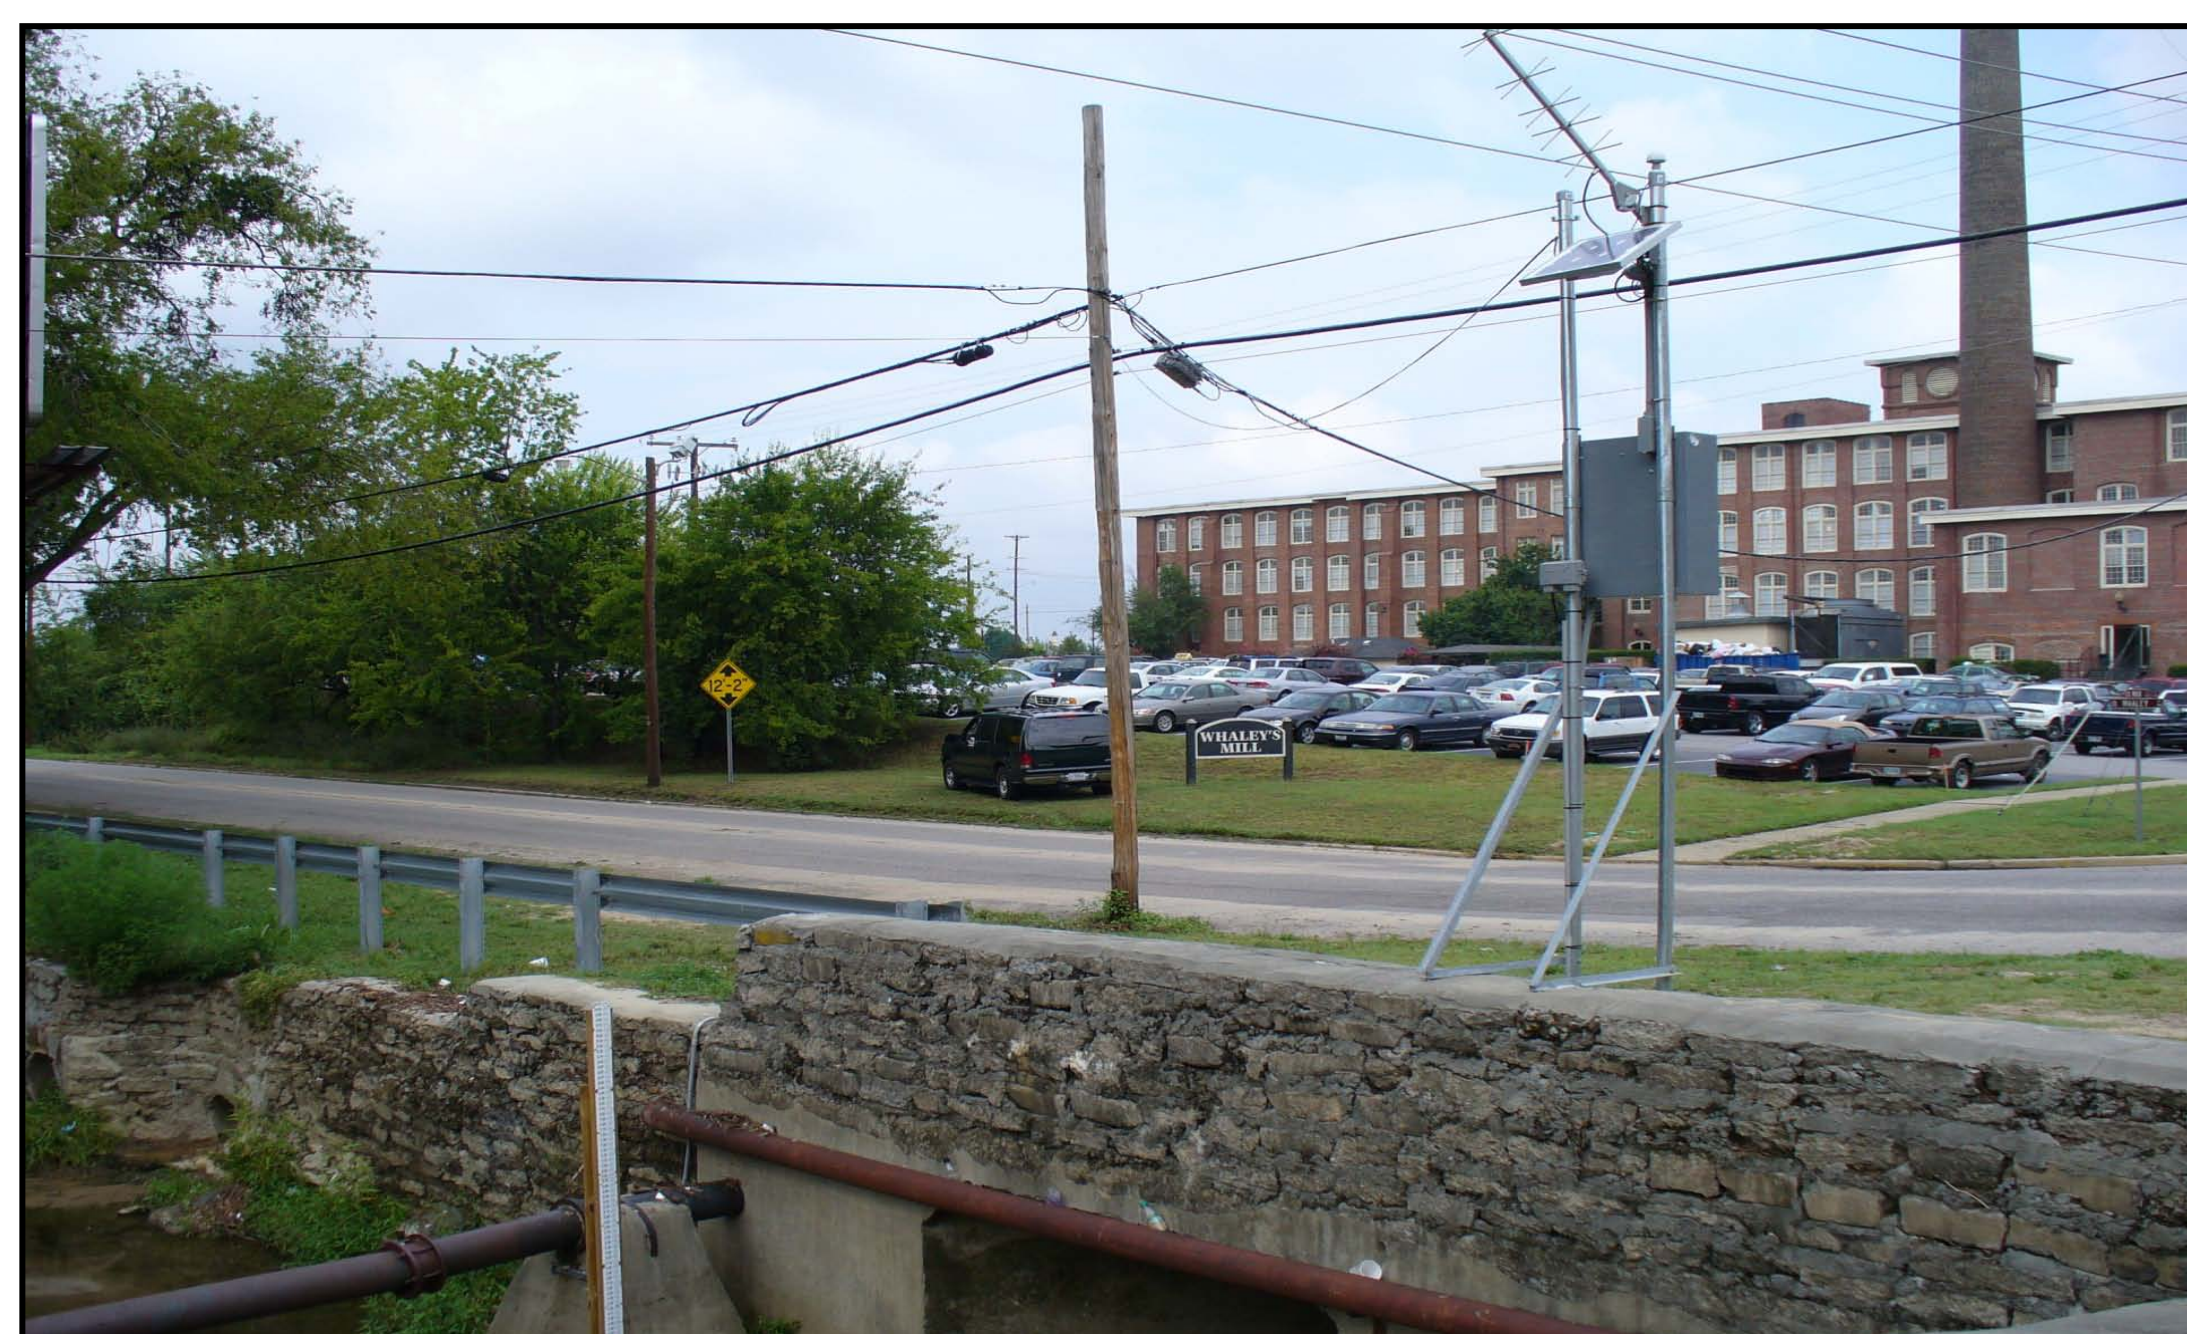
Whaley and Main Street Gauge

- The terrain of Columbia is quite hilly and highly urbanized. Two branches of Rocky Branch Creek flow between three hills and come together and flow through the USC Campus then to the Congaree River.
- Heavy urbanization plus hilly terrain makes it prone to flash flooding.
- Because of recurring flood events, the City of Columbia installed a gauging system on Rocky Branch Creek in 2007 for notification of flood threats.

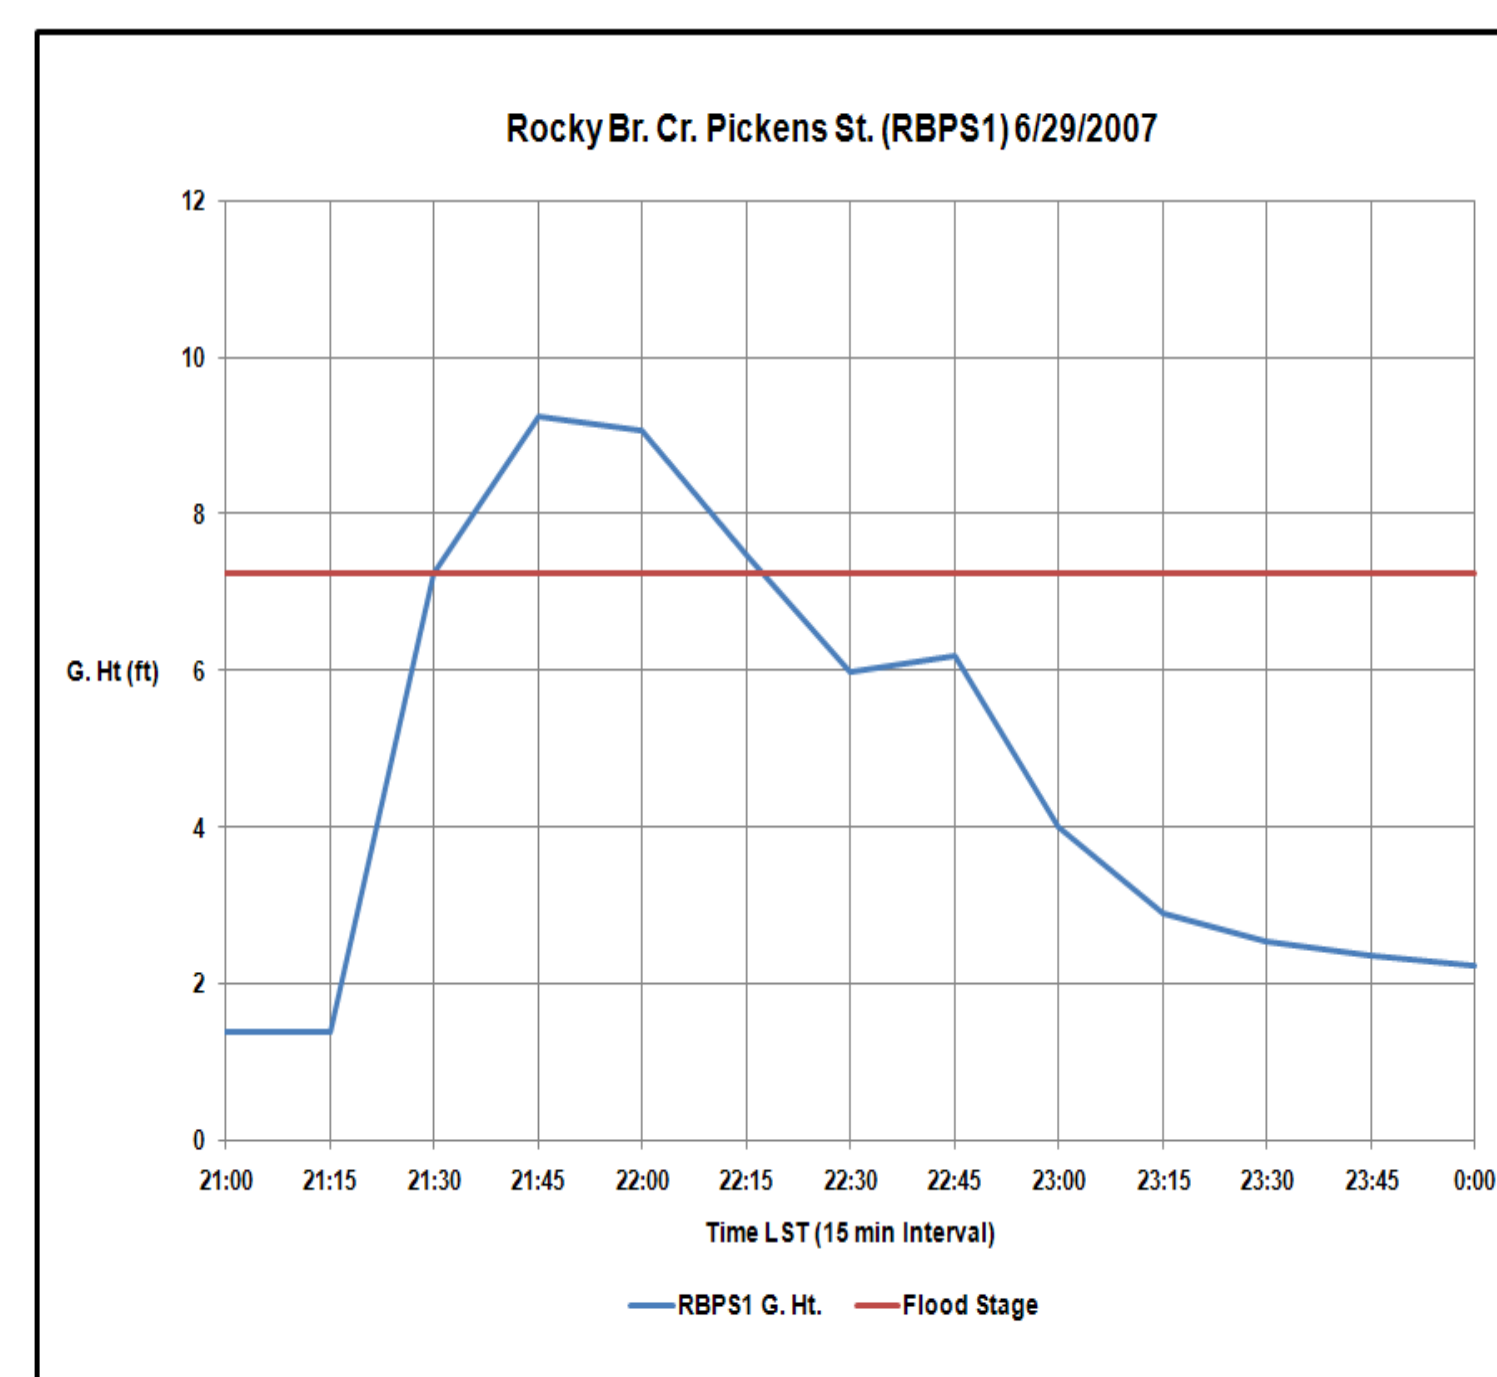
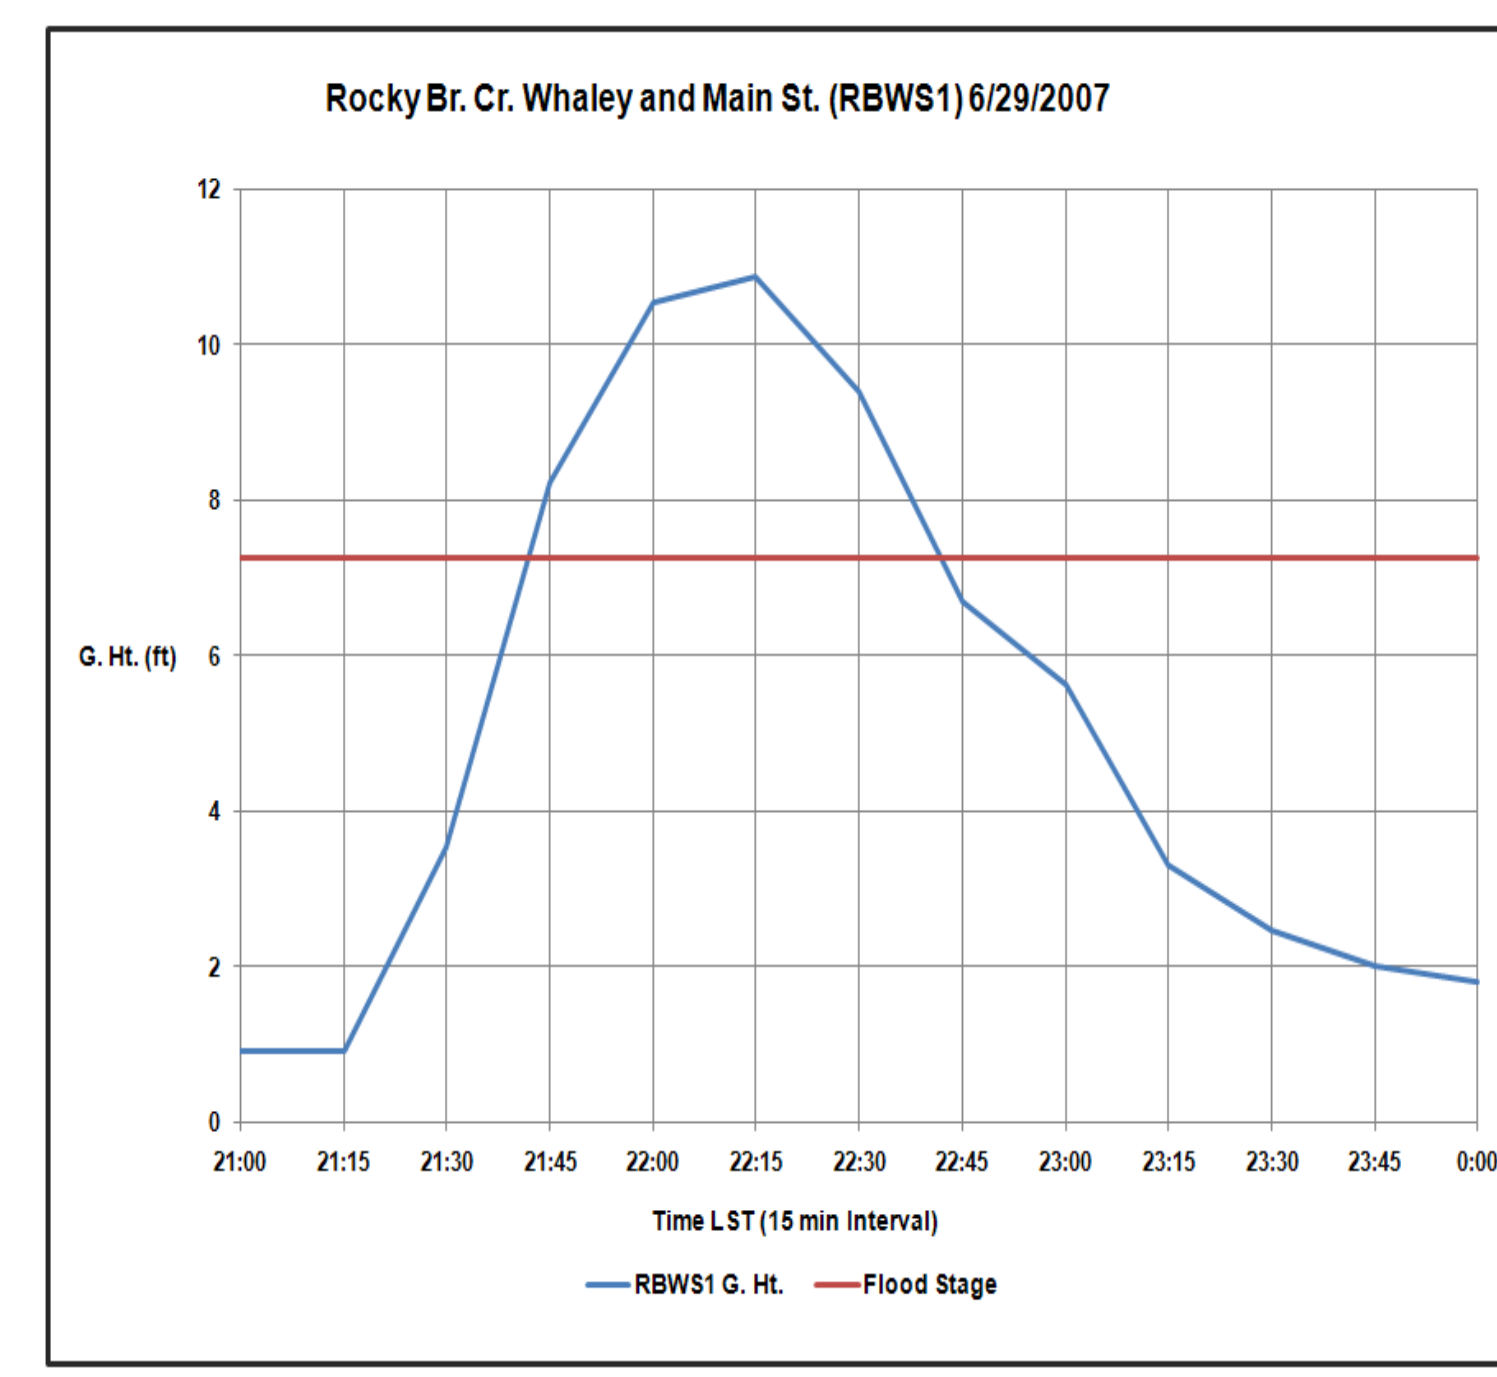
Gauges showed the rapid flood response time of Rocky Branch Creek.

- The gauging system provides little lead time for issuing Flash Flood Warnings.
- Available rainfall measurements were examined to see if they could help forecasters make better warning decisions and increase lead time.
- There are 2 ASOS sites near the Rocky Branch Basin.
  - Columbia Metropolitan Airport (CAE), 6 miles from the basin
  - Owens Field (CUB), 2 miles from the basin
- University of South Carolina (USCS1) had 24 hr. rainfall data till May 3, 2010.

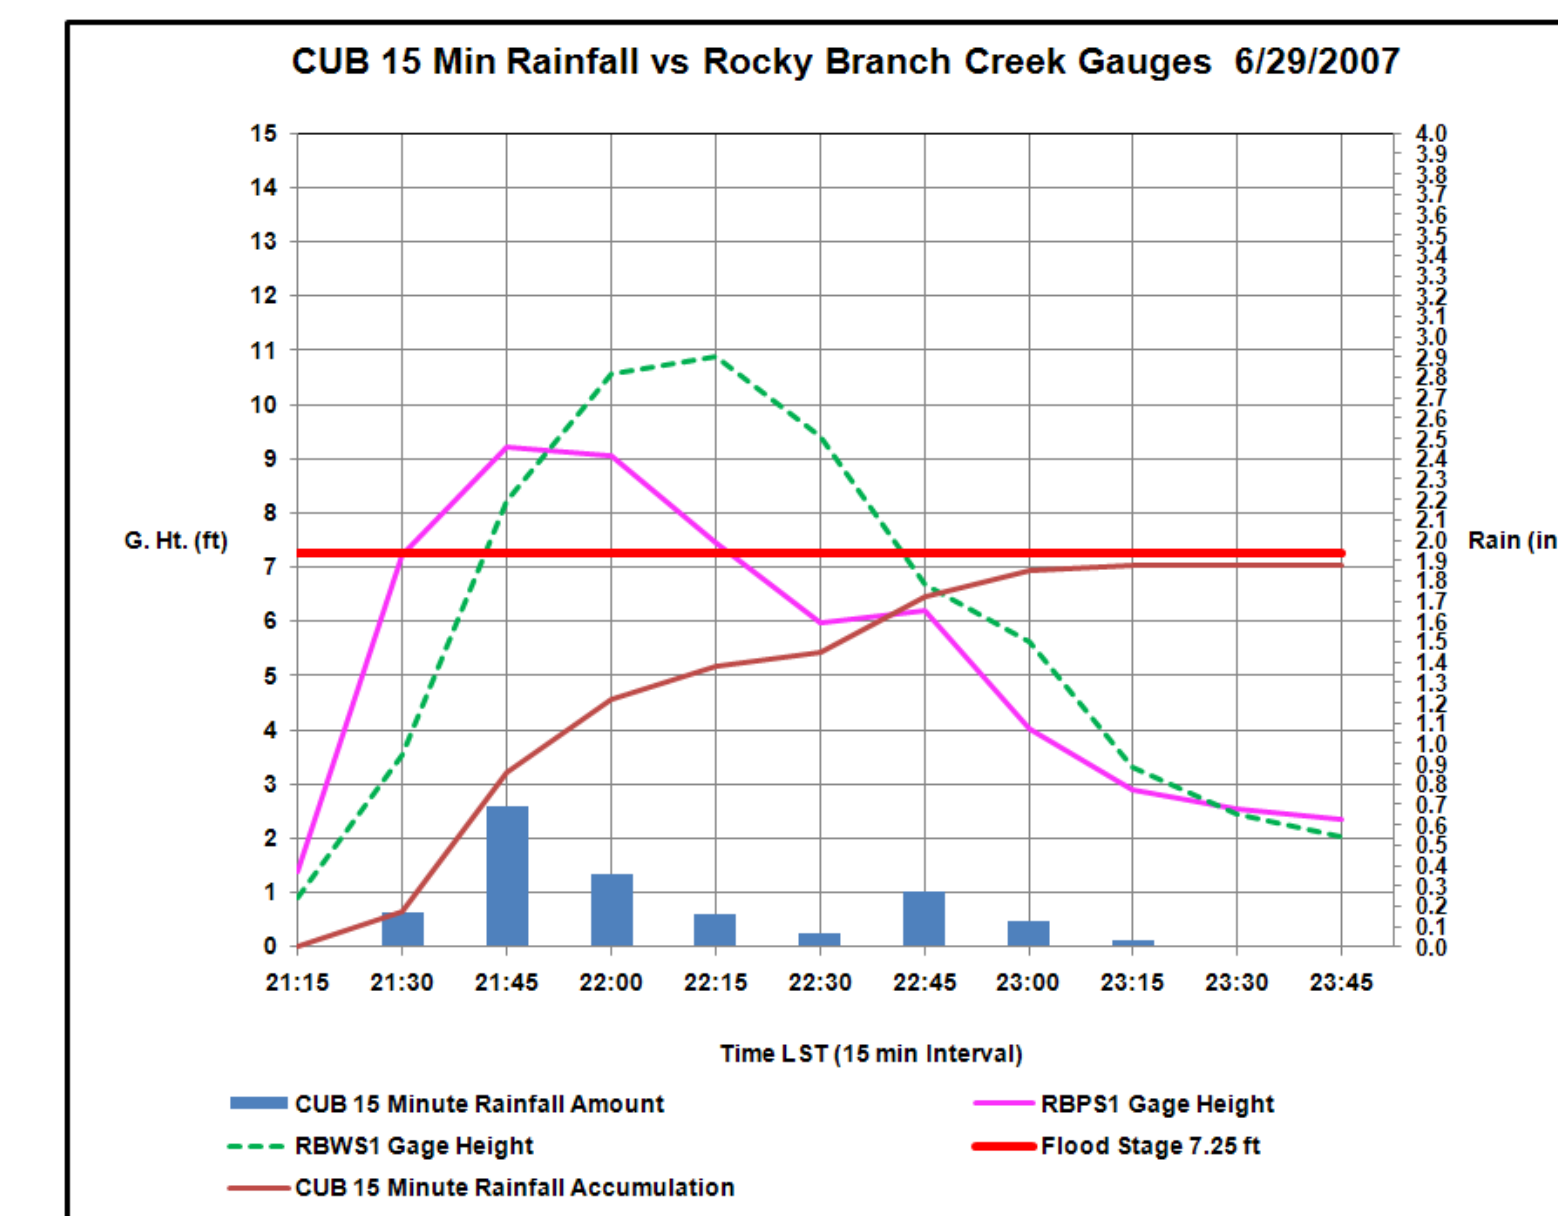
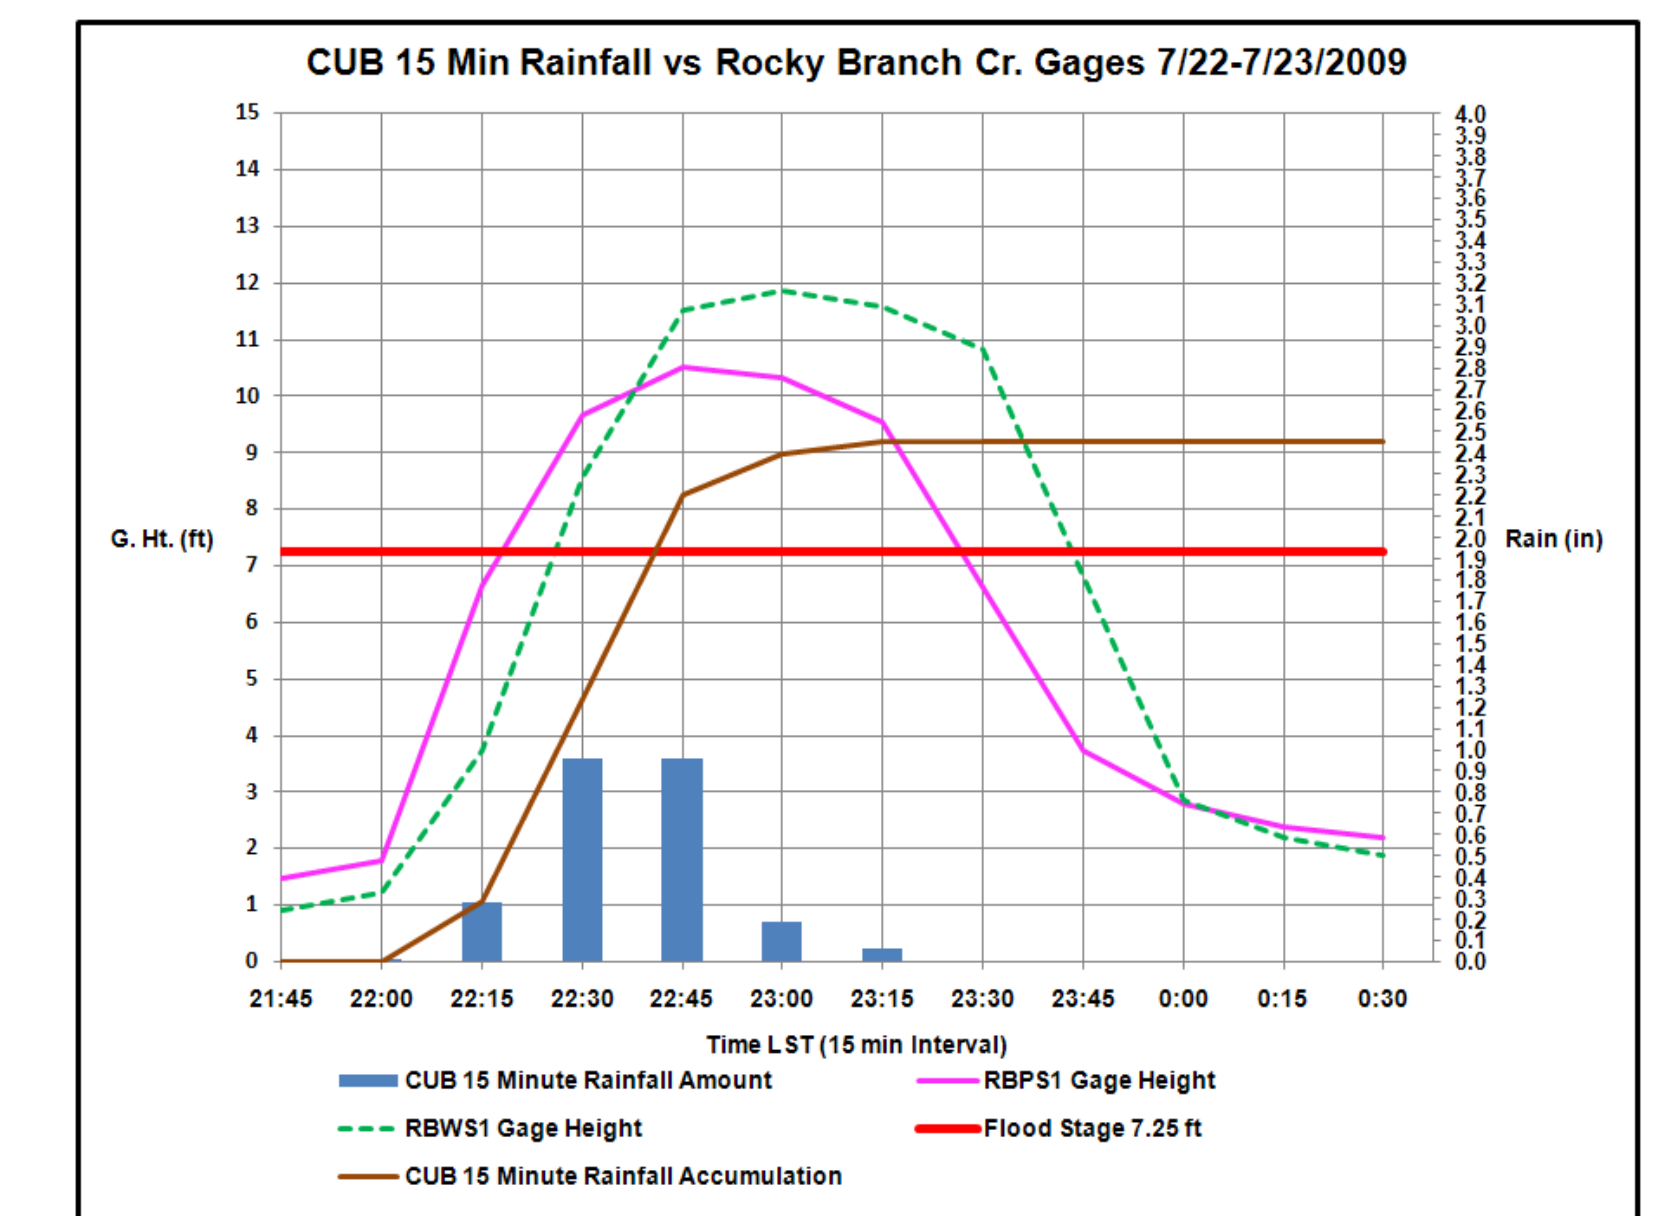
CUB rainfall amounts did not closely correspond to the resultant rise of the creek.

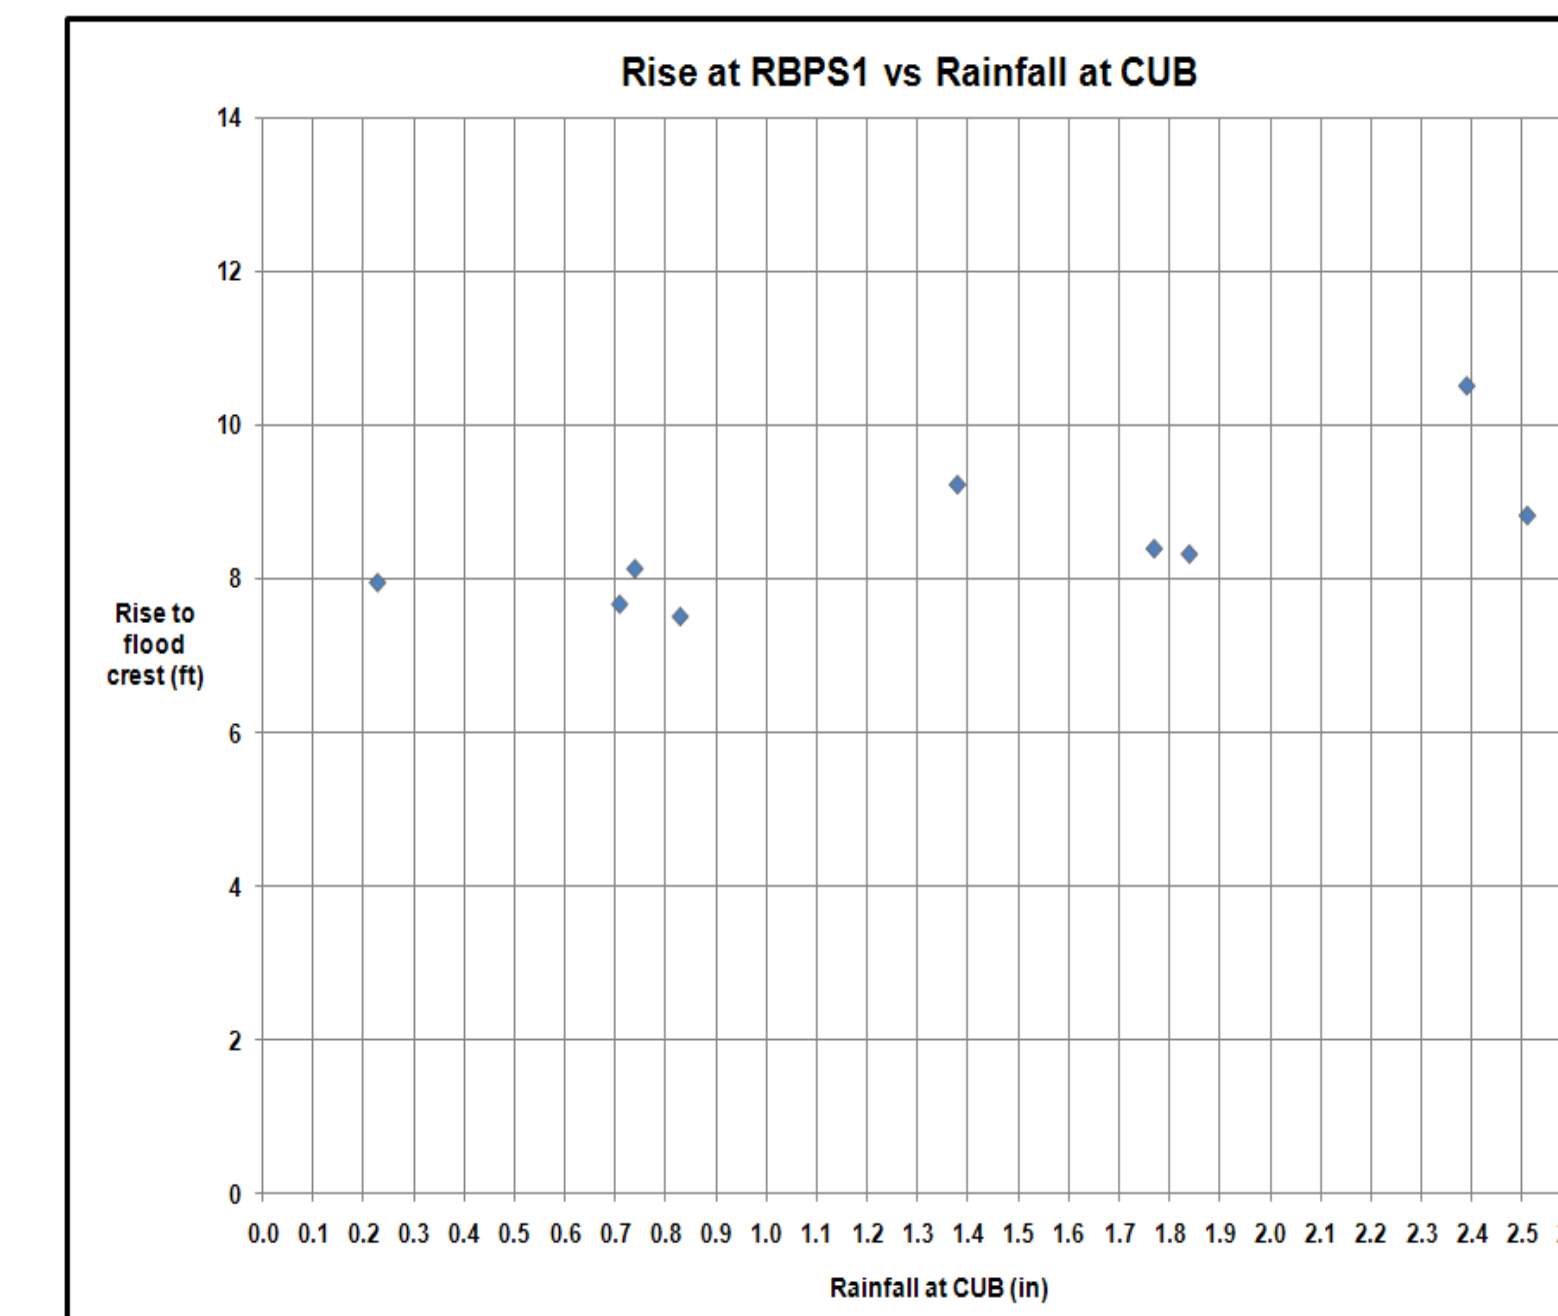
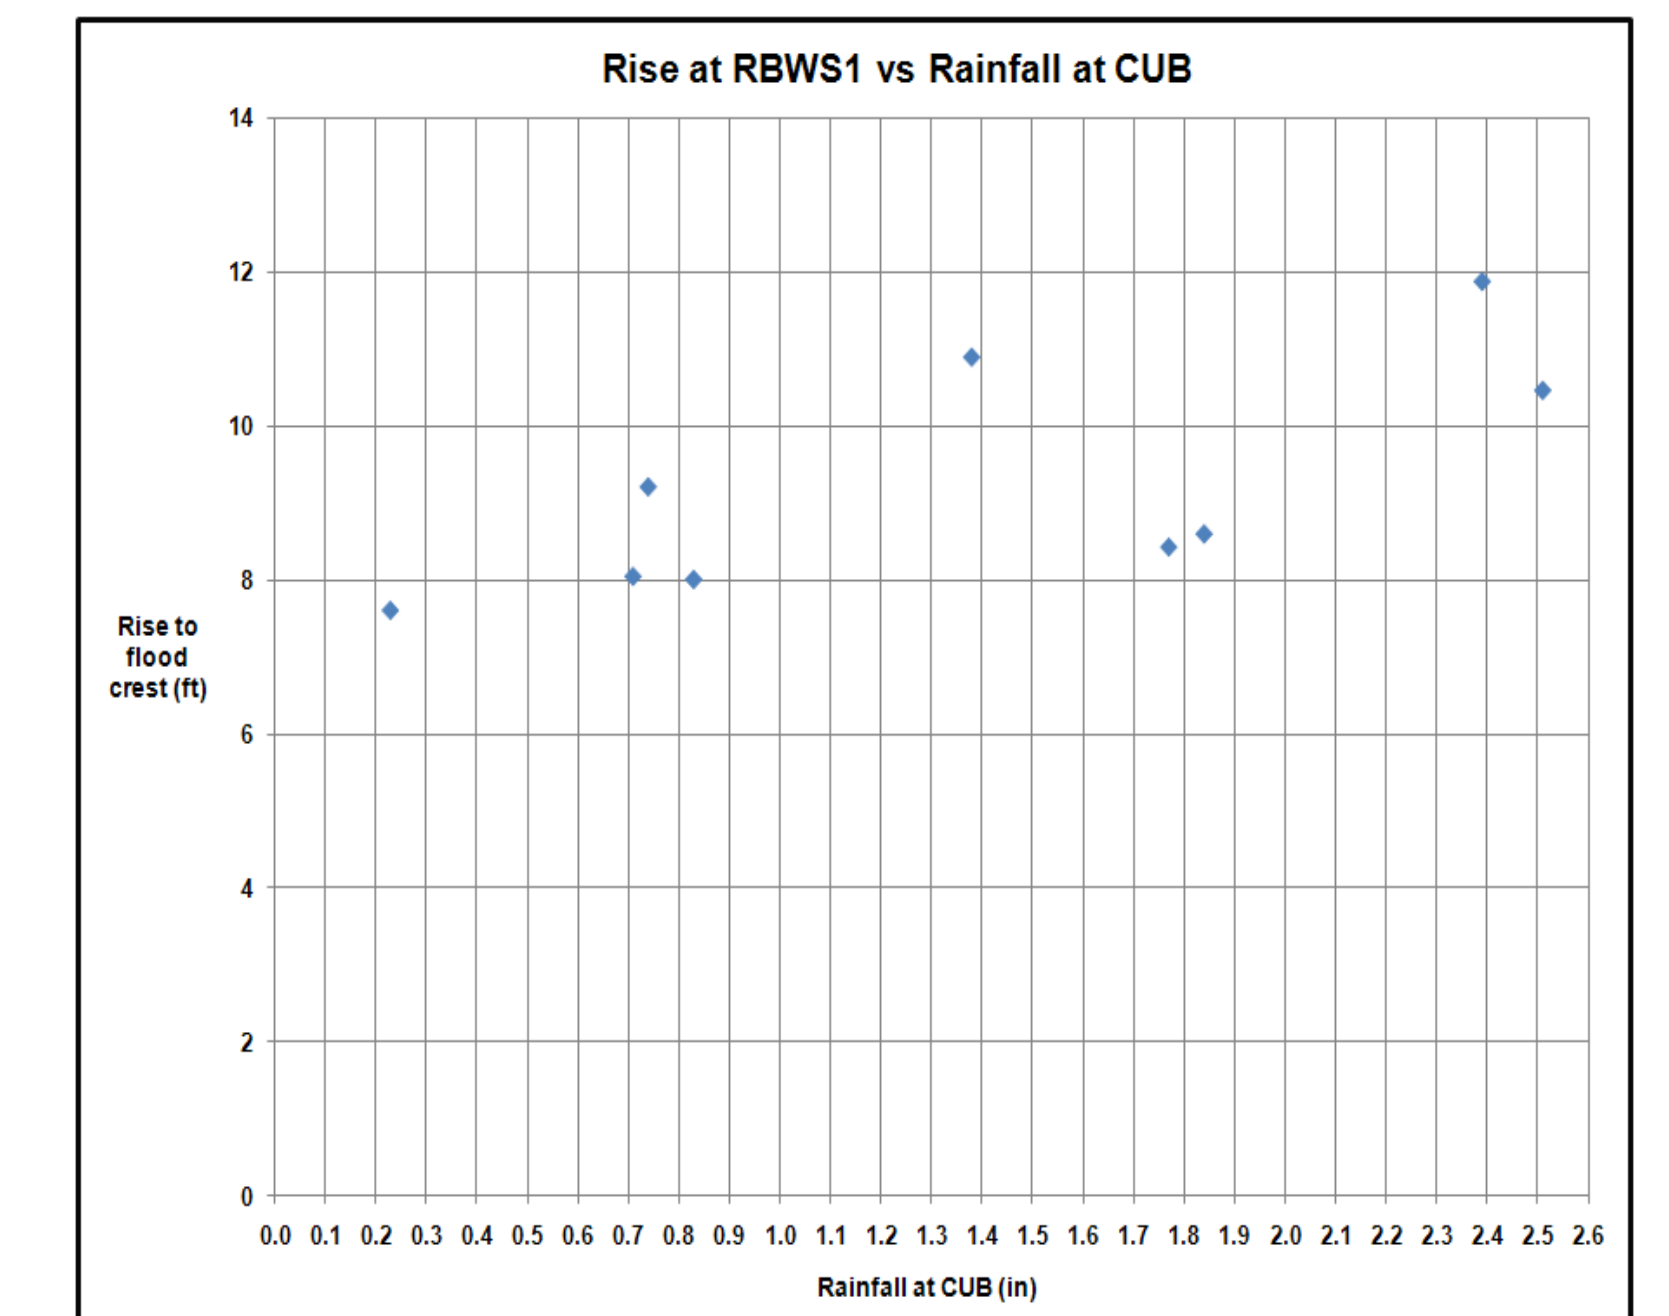
The scatter plots confirmed this observation.

- Nine flood cases over the past 3 years were selected from the Pickens Street (RBPS1) and Whaley and Main Street (RBWS1) gauges.
- CUB 15 minute rainfall data (matches the gauge data resolution) was used because CUB is only 2 miles from the basin whereas CAE is 6 miles from the Rocky Creek basin.
- Scatter plots were constructed comparing rainfall amounts to flood crests for both RBPS1 and RBWS1.

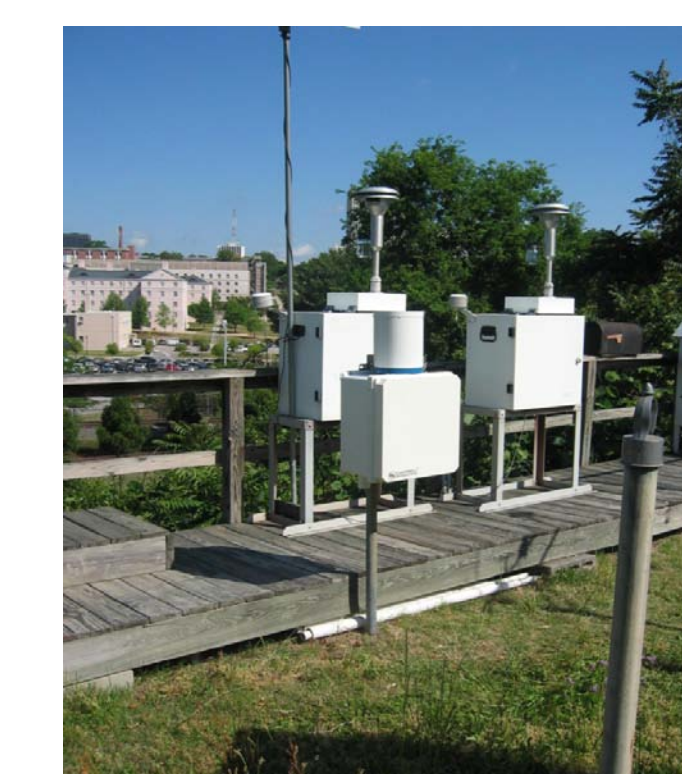
- On May 3, 2010, the National Weather Service (NWS) activated a tipping bucket rain gauge at the USC COOP site.
- The gauge will give the NWS the capability to get 5 minute rainfall data within the basin.
